INSPECTION OF BUSES WITH TEST BRAKE BLOCK

Date of Inspection: August, 9 2016

Location: Palm Tran North County Maintenance Shop
3201 Electronics Way
West Palm Beach, FL 33407

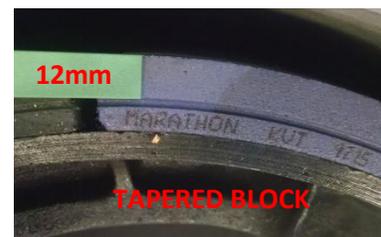
Front Block FMSI # 4715A

Overall thickness at shoe center, anchor .798", cam .842 (this is a tapered brake block design)

Thickness above wear indicator, approximately 12mm (.472")

The design of the front 4715A lining is a tapered brake block that is thicker at the center than it is at the cam and anchor ends of the shoe. New tapered frictions are engineered to wear first at the thicker center apex of the shoe. Eventually, as the shoe wears out the “tapered” brake block wears toward that of a non-tapered block. Early in the service life of a tapered block wear rates are greater at the center contact area than later in the friction life cycle. Because of this design, percentage of shoe-to-drum contact area is less in the early stages and this contact area increases as the brakes wear.

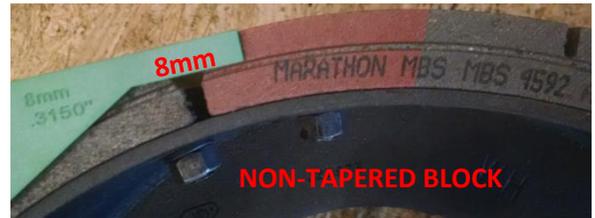
Rear Block FMSI # 4592A

Overall thickness at shoe center, anchor and cam .750"
(this is a parallel, non-tapered brake block design)
Thickness above wear indicator, approximately 8mm (.315")

The design of the rear 4592A lining is a straight, non-tapered brake block. Therefore, with a new brake drum this friction has a larger “footprint” of new shoe-to-drum percentage than its tapered counterpart. Wear rates are generally more consistent from the cam to the anchor end of the shoe.

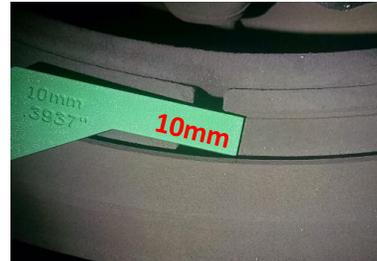
Bus 0715 (front)

Approximate lining thickness at shoe center:
RF 10mm (wear 2mm), LF 10mm (wear 2mm)
Overall thickness approx. 23/32"
Visible drum brake surface – normal
RF drum, no lip
LF drum, very slight lip

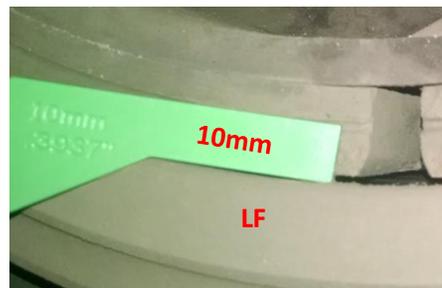
Bus 0802 (front)

Approximate lining thickness at shoe center:
RF 10mm (wear 2mm), LF 9mm (wear <3mm)
Overall thickness approx. RF 23/32", LF 22/32"
Visible drum brake surface – normal
RF drum, no lip
LF drum, no lip

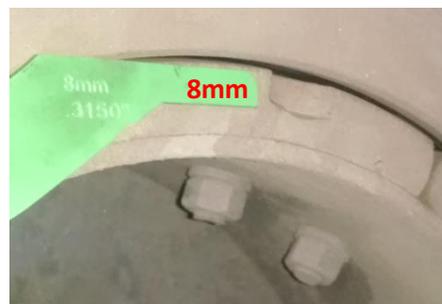
Bus 710 (rear)

Approximate lining thickness at shoe center:
RR 8mm, LR 8mm (no significant visible wear)
Overall thickness approx. 24/32"
Visible drum brake surface – normal, no lip

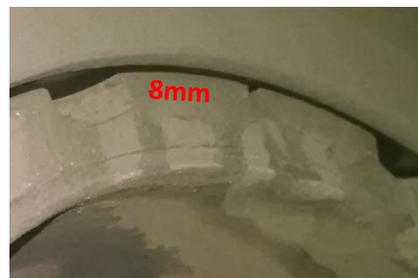
Bus 1207 (rear)

Approximate lining thickness at shoe center:
RR 8mm LR 8mm (no significant visible wear)
Overall thickness approx. 24/32"
Visible drum brake surface – normal, no lip but
some minor scoring near open diameter of RR drum,
nothing to be concerned about

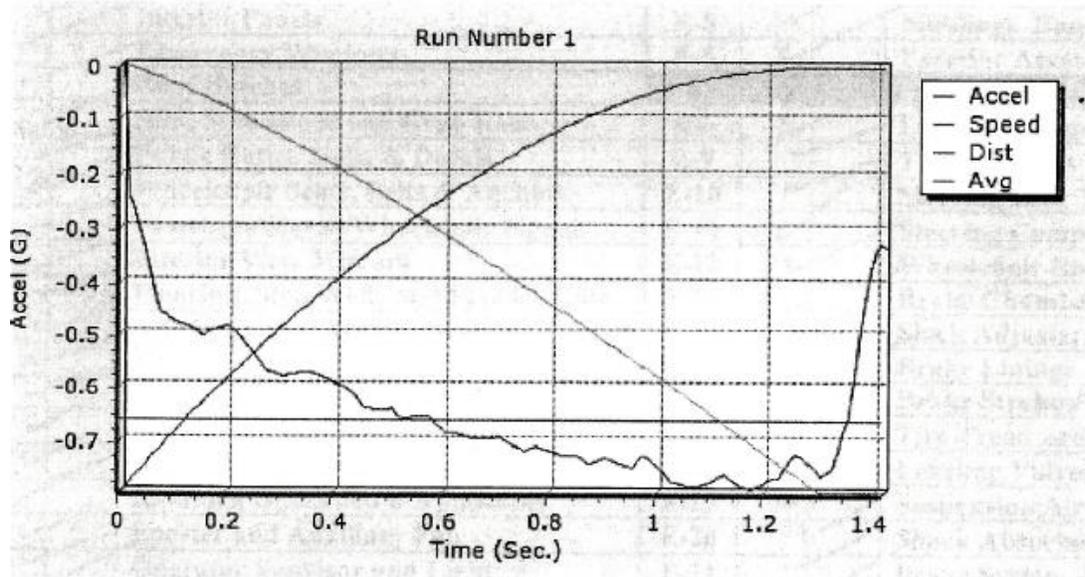
Bus 0715

Transit Report

VC4000 Run Information	
Run No	1
Date	6/17/2016 7:12:00 AM
Vehicle	715
Run Time	1.3
Speed	18.7 MPH
Distance	19.6 ft
Adjusted Distance	@(20 MPH) = 22.1 ft
Average	-0.657
Peak Accel	-0.796 at 1.170 sec
First Peak Accel	-0.719 at 0.740 sec
G Threshold	-0.200 G
G Summation	3D (XYZ)
Notes

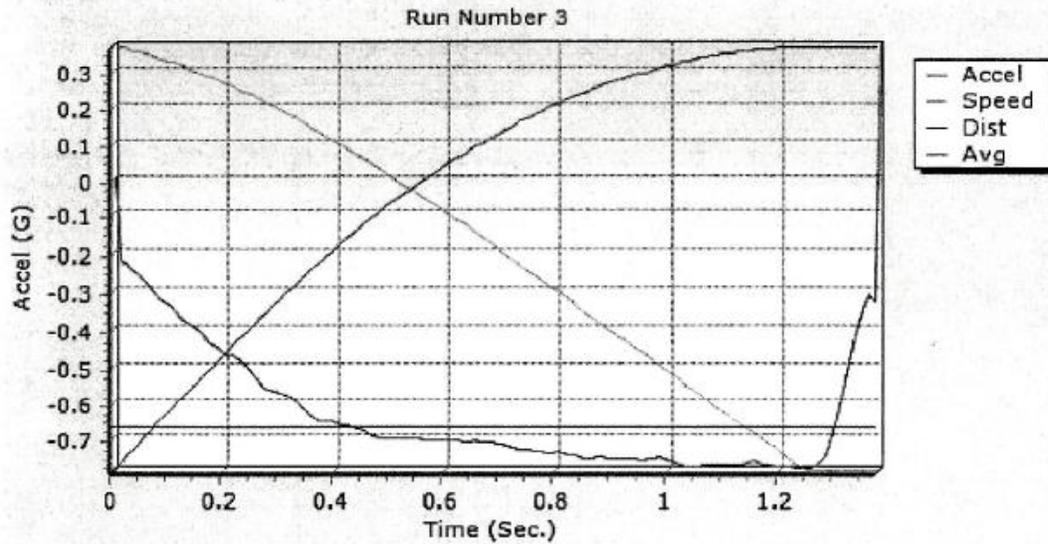
Bus 0802

Transit Report

VC4000 Run Information	
Run No	3
Date	7/9/2016 6:54:00 AM
Vehicle	802
Run Time	1.25
Speed	17.9 MPH
Distance	18.4 ft
Adjusted Distance	@(20 MPH) = 22.4 ft
Average	-0.654
Peak Accel	-0.790 at 1.250 sec
First Peak Accel	-0.737 at 0.740 sec
G Threshold	-0.200 G
G Summation	3D (XYZ)
Notes

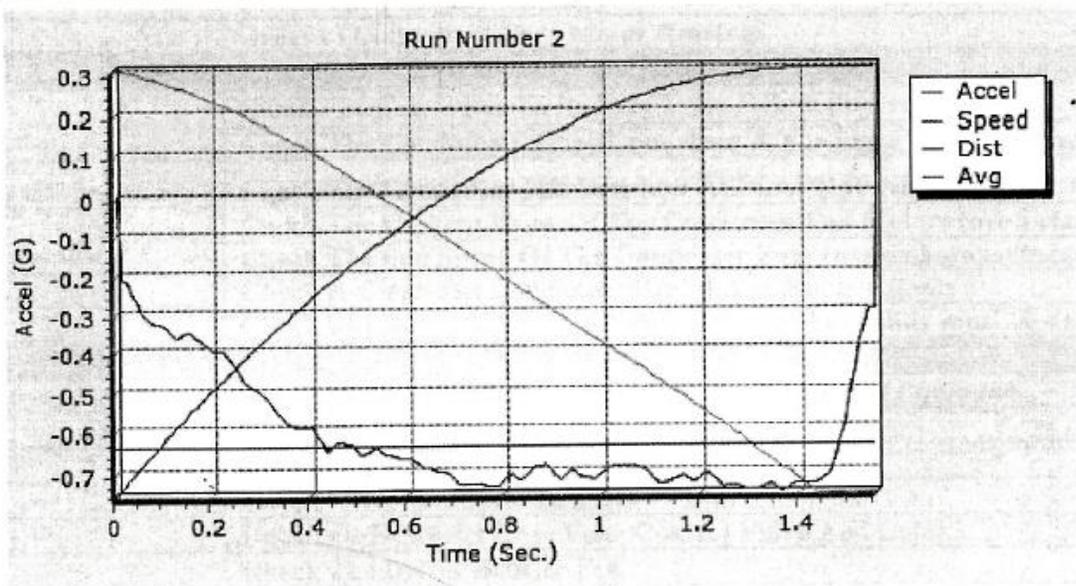
Bus 0710

Transit Report

VC4000 Run Information	
Run No	2
Date	7/26/2016 2:55:00 PM
Vehicle	710
Run Time	1.44
Speed	19.9 MPH
Distance	23.3 ft
Adjusted Distance	@(20 MPH) = 23.6 ft
Average	-0.628
Peak Accel	-0.754 at 1.360 sec
First Peak Accel	-0.734 at 0.740 sec
G Threshold	-0.200 G
G Summation	3D (XYZ)
Notes

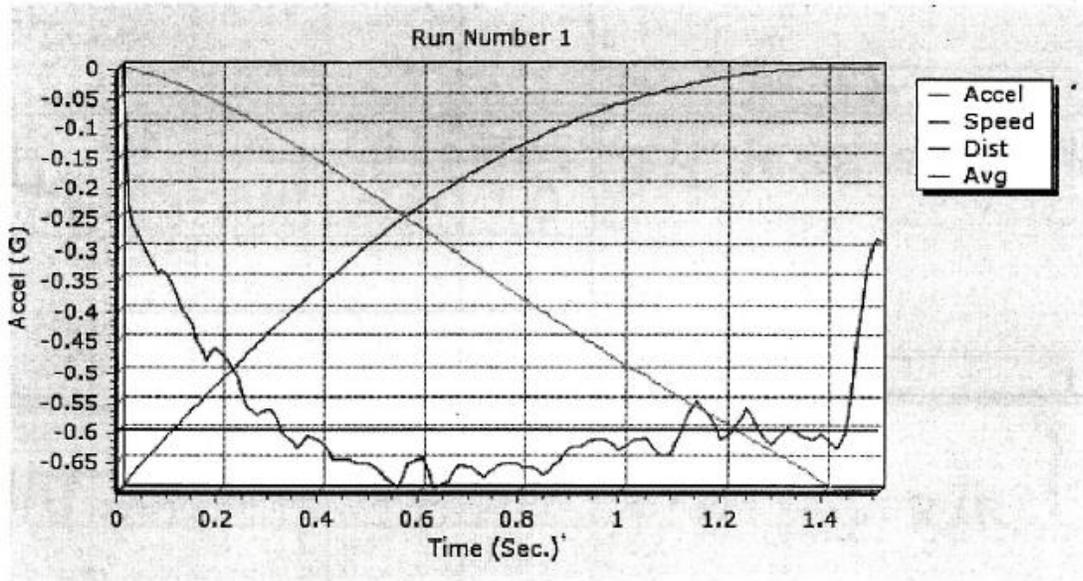
Bus 1207

Transit Report

VC4000 Run Information	
Run No	1
Date	7/24/2016 7:36:00 AM
Vehicle	1207
Run Time	1.42
Speed	18.5 MPH
Distance	20.2 ft
Adjusted Distance	@(20 MPH) = 23.5 ft
Average	-0.594
Peak Accel	-0.699 at 0.550 sec
First Peak Accel	-0.699 at 0.550 sec
G Threshold	-0.200 G
G Summation	3D (XYZ)
Notes
